**The Townes at Kettle Creek Owner's Association**  
**3095 Ironton Creek Point**  
**Colorado Springs, CO 80908**

**Level 1 Reserve Analysis**

**Report Period – 01/01/08 – 12/31/08**

**Date of Property Inspection – March 10, 2008**  
**Report Prepared by – G. Michael Kelsen**  
**Property Inspected by - G. Michael Kelsen & Ryan Longhenry**  
**Main Contact Person - Mr. Jason McIntyre, Community Manager**

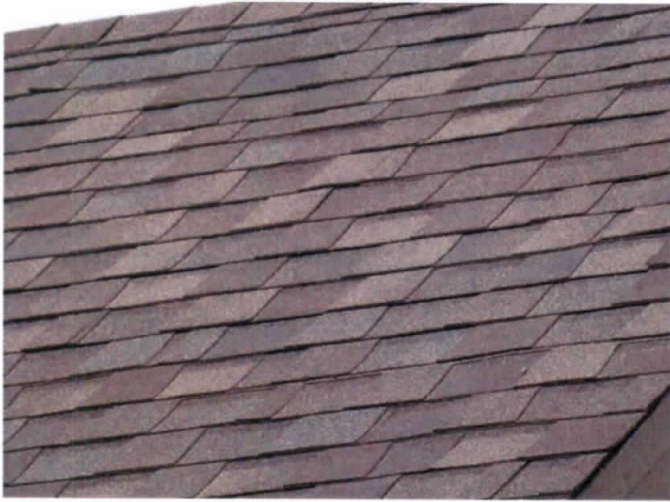
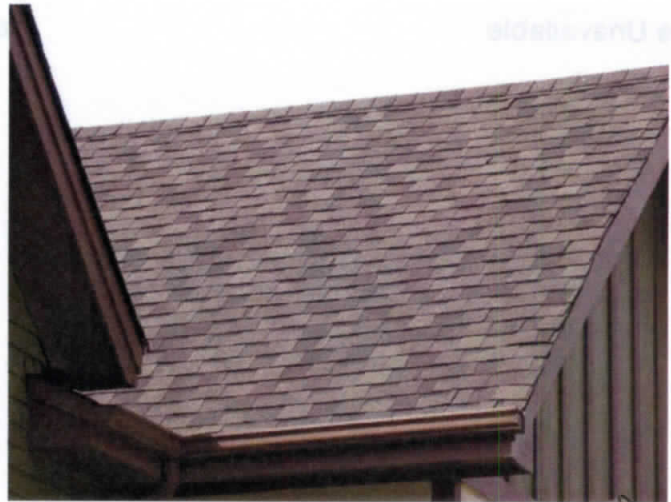
Comp #: 105 Comp Shingle Roof - Replace (1)

Roofs are all new and in good condition with no significant signs of unusual wear. This roof appears to be a "30-year" rated shingle. Despite this rating, replacement typically needs to occur within 20 - 22 years due to weather elements such as hail, wind, and temperature fluctuations. It is not recommended that an overlay is applied when a roof needs to be replaced. With overlays, it may cause further damage from hailstones due to being a softer surface and wind due to uneven surfaces. Therefore, Reserve funding includes complete tear off and replacement. To ease budgeting concerns, and based on the when these buildings were built, we have split the property into 2 phases.

\$150/square; Estimate to remove and replace

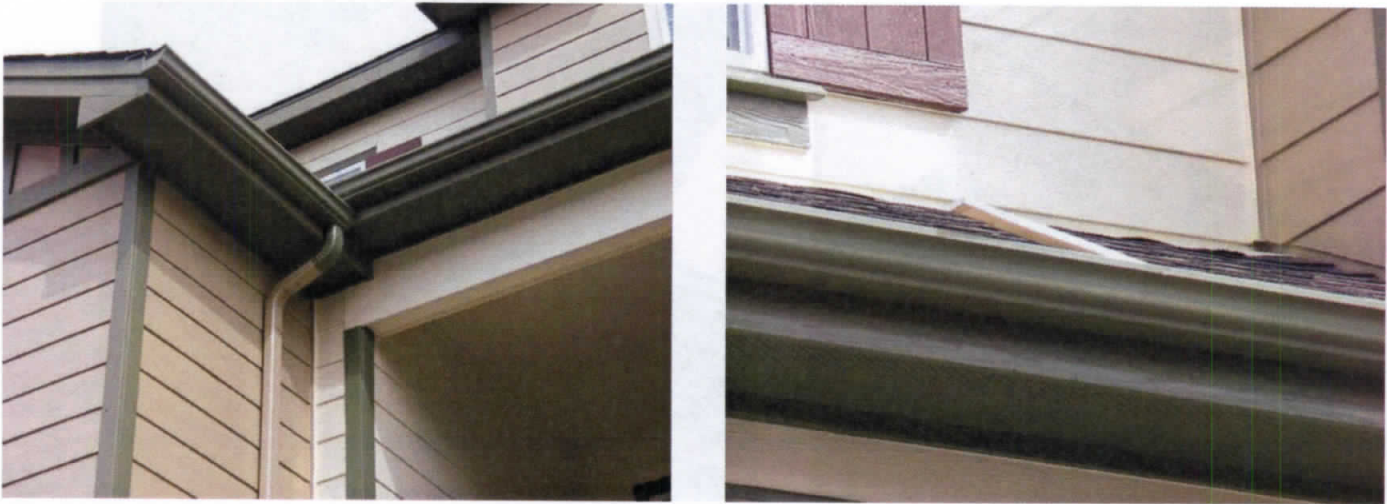
Comp #: 120 Gutters/Downspouts - Replace (2)

These buildings have not been built yet. It is expected that construction of these buildings will be completed by the end of 2008. It is assumed similar quality roof materials will be installed on these roofs. Typically, properties replace rain gutters and downspouts at the same time as roofing materials to ensure proper size for drainage. Due to large amount of gutters and downspouts, we recommend replacing this line item on the same cycle as the roofing.

\$4.00/LF; Estimate to replace

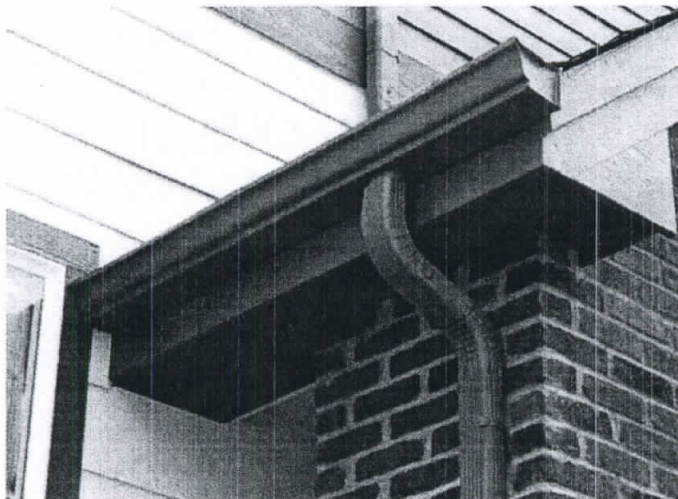
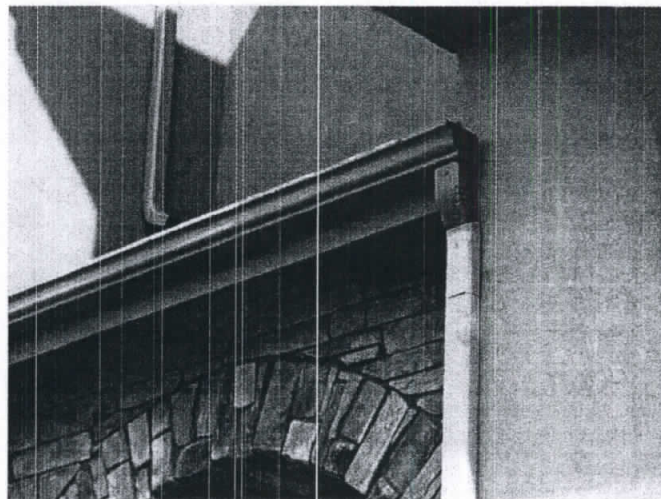
Comp #: 120 Gutters/Downspouts - Replace (1)

No unusual conditions of the rain gutters or downspouts were observed during inspection, since the areas are new. Typically, properties replace rain gutters and downspouts at the same time as roofing materials to ensure proper size for drainage. Due to large amount of gutters and downspouts, we recommend replacing this line item on the same cycle as the roofing. To ease budgeting concerns we have split the property into 2 phases.

*Best Cost:* \$16,700  
\$4.00/LF; Estimate to replace

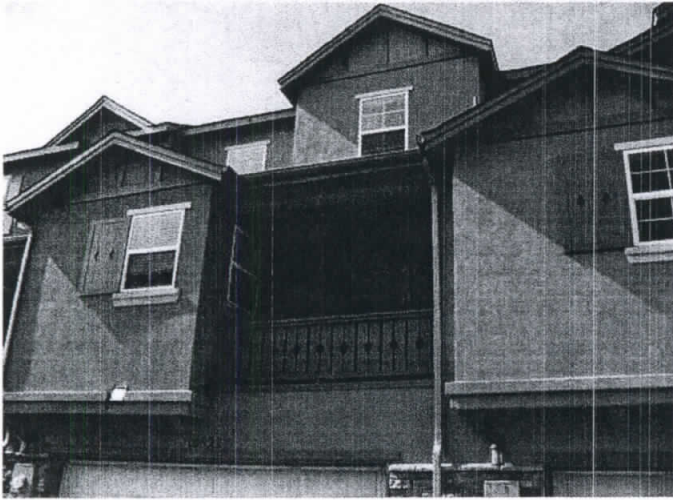
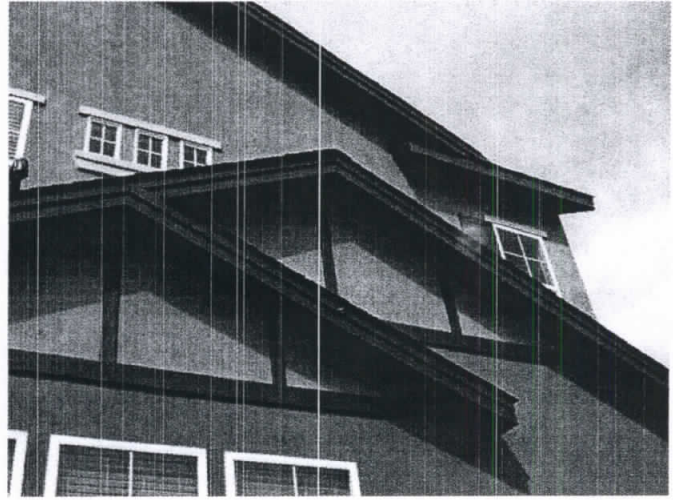
Comp #: 202 Wood Trim - Repaint

No unusual conditions observed at time of inspection. All but one of the buildings that will have stucco have been constructed to date, so there should not be any signs of deterioration since buildings are new. In this climate, we recommend painting wood surfaces and trim every 3 - 5 years, depending on the quality of past paint applications. Since these are darker colors, a shorter life expectancy can be expected.

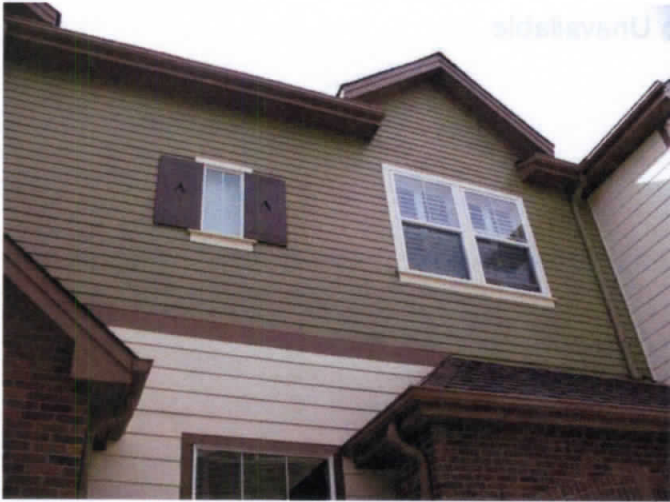
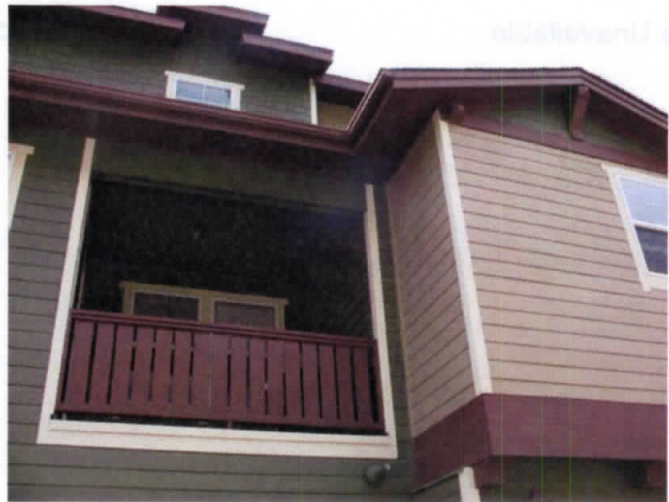
Comp #: 204 Building Ext Surfaces - Repaint (1)

Majority of colors were still bright and vibrant at time of inspection. Darker colors (greens, reds, and browns) are subject to fading earlier than brighter and lighter colors (tan and light gray). The fiber cement product painting cycle ranges from 5 - 10 years due to the type of material. Due to the majority of the buildings being darker colors, in order to maintain the appearance of the property, we suggest painting every 6 years. We have split the property into two different painting cycles to spread out the expense and ease budgeting concerns. Areas should be touched up on an as needed basis between painting cycles to maintain the appearance of the community.

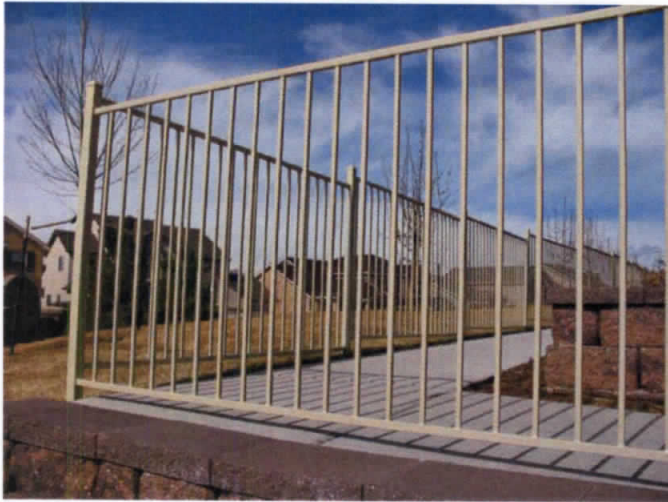
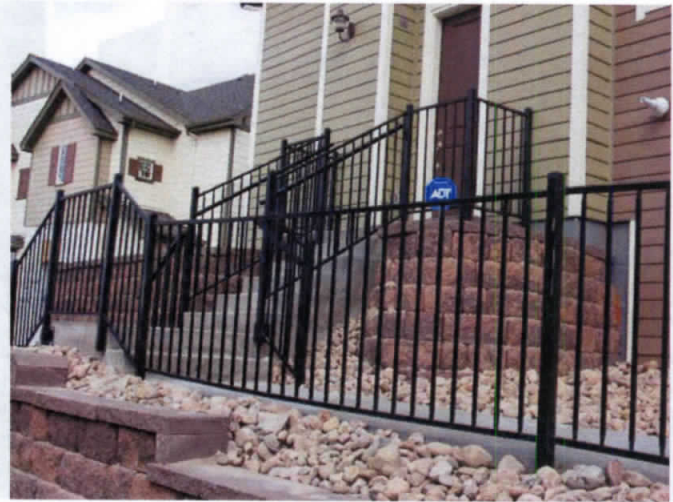
Comp #: 207 Iron Fencing - Repaint

All surfaces are relatively new and in good condition with no major signs of faded or dull paint. In this climate, we recommend repainting this component every 3 - 4 years to maintain appearance and protect metal surfaces. Remaining life based on age and current condition.

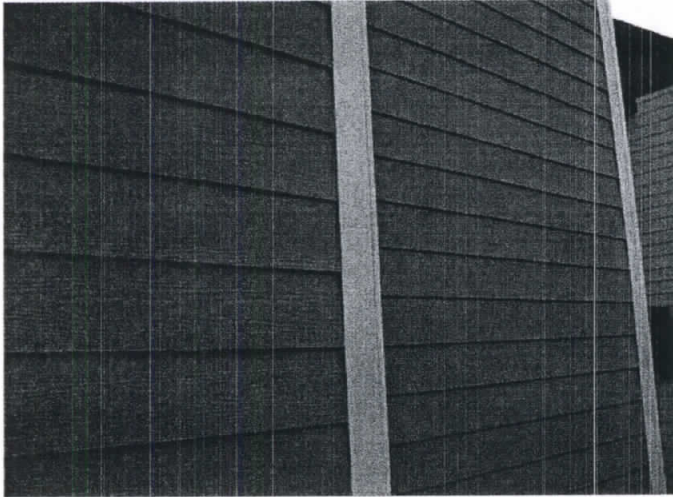
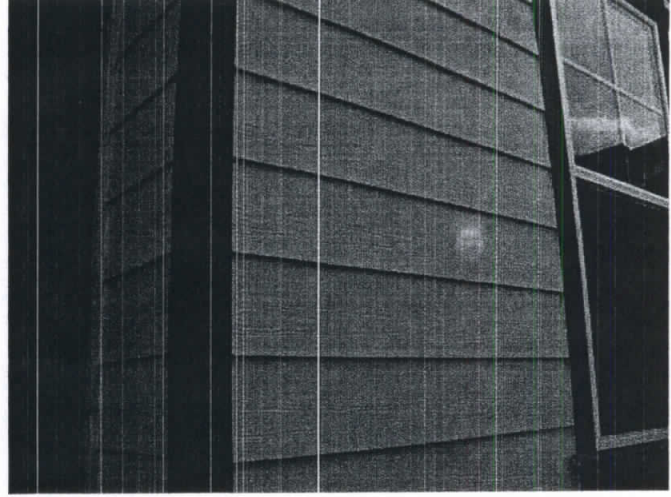
Comp #: 304 Fiber Cement Siding - Replace

There were no major problems noted on the buildings that were finished. There were a few cracks noted on the corners of the pieces of siding. Any minor repairs can be performed as a maintenance issue as part of prep work before painting. According to the manufacturer of this product, this material has a 50+ year warranty against defects that will require replacement. Therefore, at this time, we do not suggest Reserving for replacement of siding or trim materials. If deterioration is observed in future years, there is plenty of time available to add to Reserves without substantially affecting the contribution rate. If replacement was needed, expect to spend approximately \$10.00/GSF or approximately \$1,325,800 at today's dollars (2008).

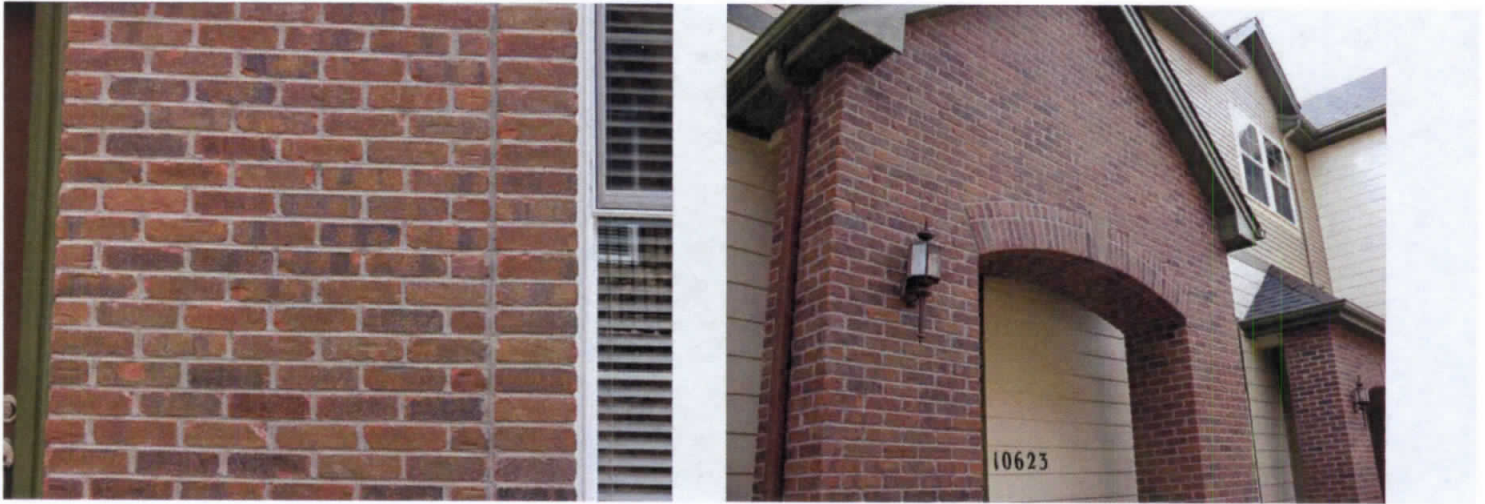
Comp #: 306 Brick - Replace

Bricks appeared to be attached to the sides of the building securely with no loose or missing material noted. Typically, bricks have an extended life expectancy and complete replacement is unlikely. There are times where minor repairs may become necessary, but this is unpredictable when and how much would occur. Repairs should be handled as a maintenance issue on an as needed basis. Reserve funding is not required for this component at this time. If it later turns out that frequent repairs are necessary, then funding could be added in future Reserve Study updates.

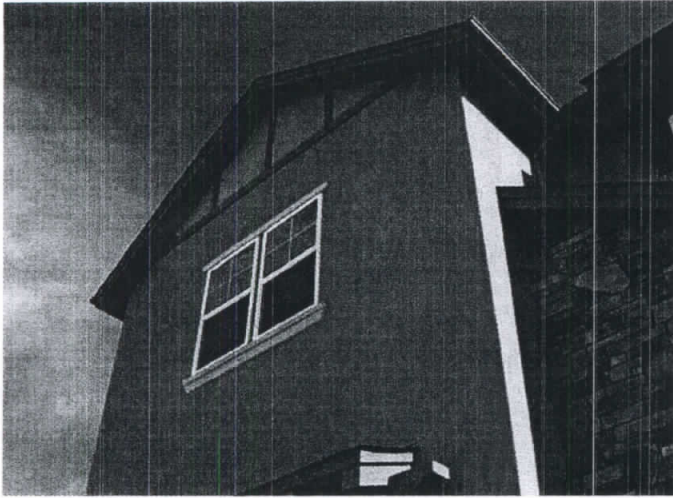
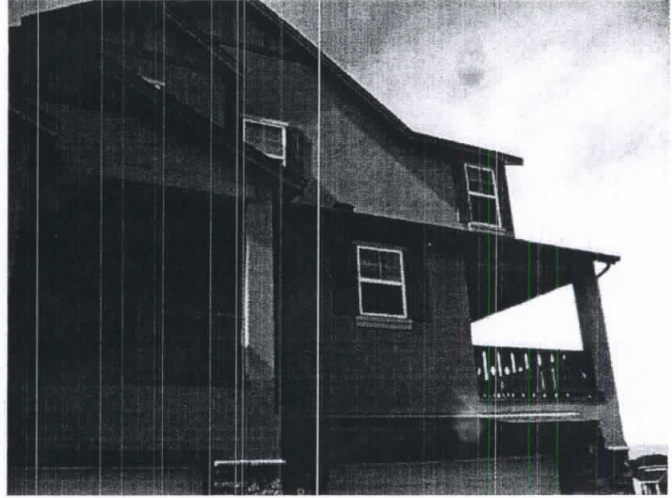
Comp #: 307 Stucco - Repair

All buildings are new and in good condition. While stucco surfaces have a long life expectancy (typically a 10 year labor warranty), it is recommended by industry professionals that it is inspected and any voids are repaired every 5 - 7 years to prevent water intrusion into substrate. It is also recommended that a new coating is applied every 10 - 15 years to maintain an appropriate appearance (see component #201). Over a period of time, minor cracks and voids will develop that will require repairing. Coordinate these repairs with a painting cycle every 12 years.

\$250/unit; Estimate to inspect and minor repairs

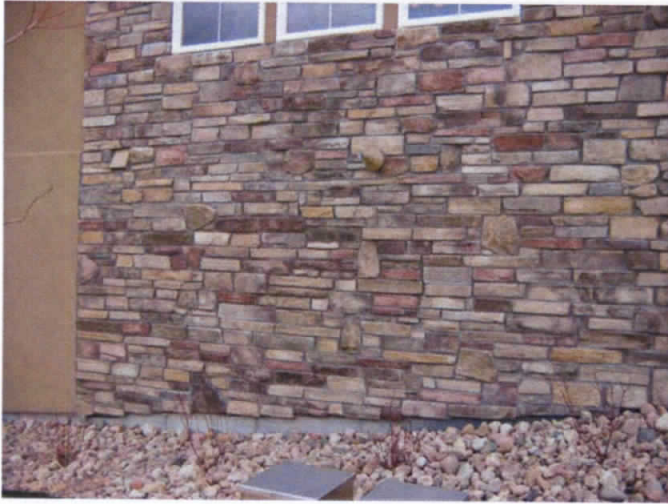
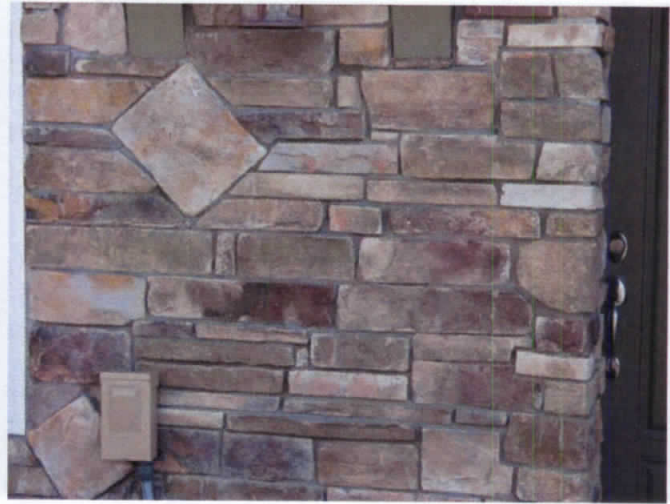
Comp #: 308 Stone - Repair

Stones appeared to be attached to the sides of the building well with no loose or missing material noted. Typically, stones have an extended life expectancy and complete replacement is unlikely. There are times where minor repairs may become necessary, but this is unpredictable when and how much would occur. Repairs should be handled as a maintenance issue on an as needed basis. Reserve funding is not required for this component at this time. If it later turns out that frequent repairs are necessary, then funding could be added in future Reserve Study updates.

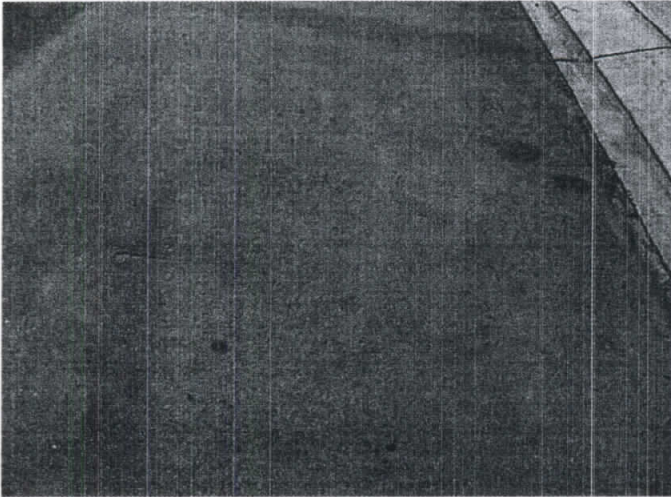
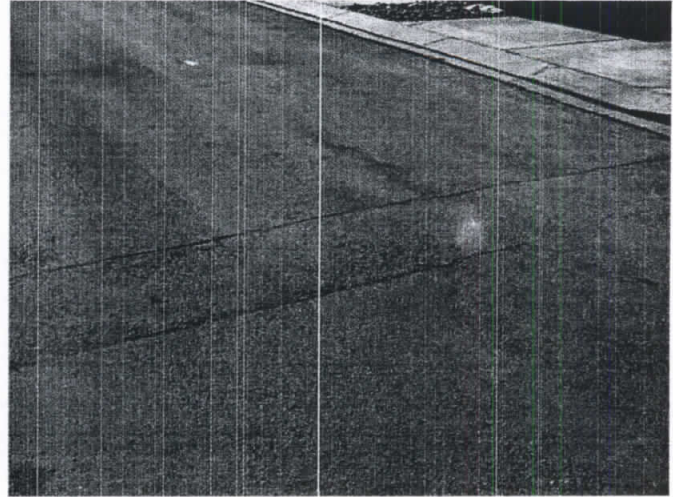
Comp #: 401 Asphalt - Overlay

The majority of the surfaces still need the final 2" lift to the finish level. This will be done once construction is complete in these areas. The surfaces that are finished are in good condition with no major cracking or structural problems observed. Asphalt overlay generally has a useful life of 20 - 25 years. Maintain seal coat schedule to ensure full useful life. The remaining life (same as the useful life) is based on the average age of all surfaces, since most of the streets will have a new surface toward the end of the year. Industry professionals recommend a seal coat within 12 months of application of the final layer.

\$1.25/GSF; Higher estimate for local repairs

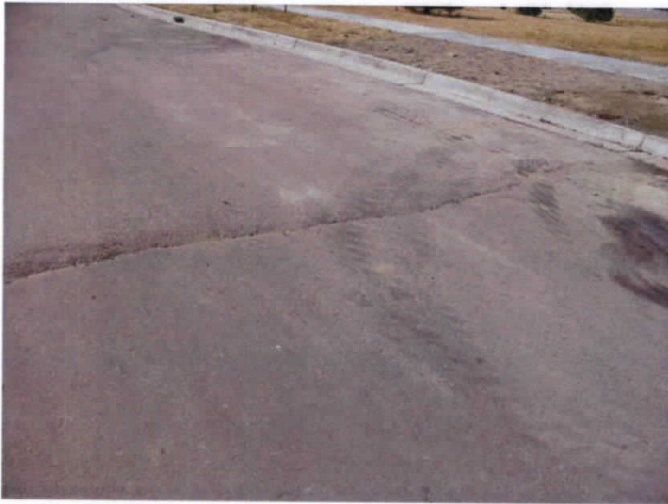
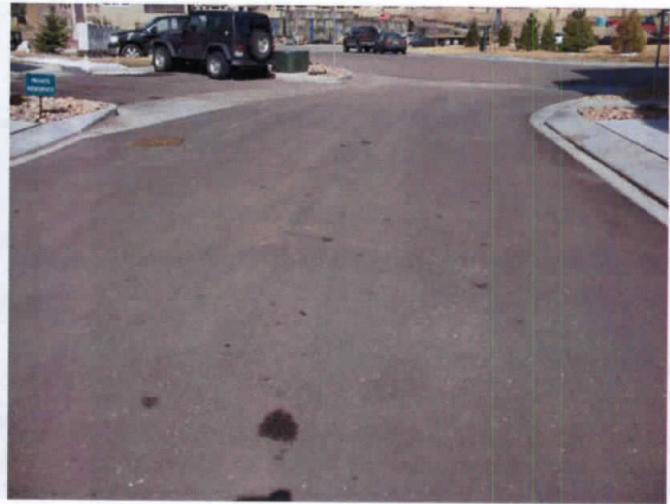
Comp #: 402 Asphalt - Seal Coat/crack fill

All surfaces will be new by the end of 2008. Approximately 2/3rd of the streets still need the final 2" lift to the proper level. Industry professionals recommend a seal coat within 12 months of application of final layer. Thereafter, in this climate, seal coating is recommended every 3 - 4 years. In between seal cycles, asphalt should be crack filled and repaired as a preventative maintenance measure to ensure maximum life expectancy from the material. Seal coating is applied to protect the asphalt from ultra-violet rays and water. This helps in slowing the process of oxidation and raveling. While acting as a protective barrier, it also maintains the appearance of the community to maintain or improve property values.

**Worst Cost:** \$5,850  
\$.11/GSF; Higher estimate includes repairs

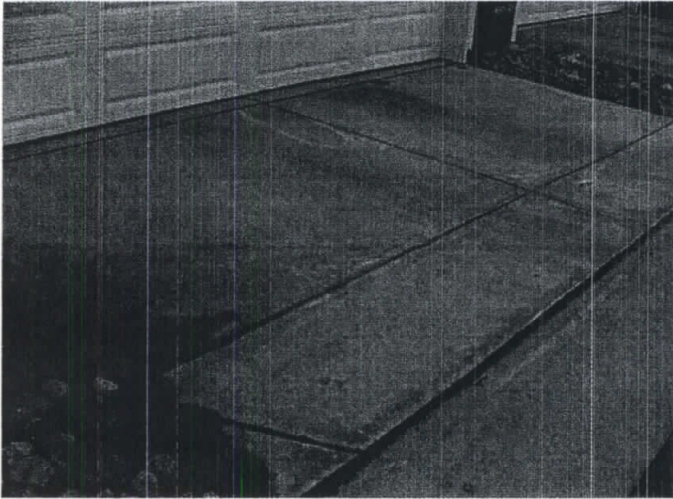
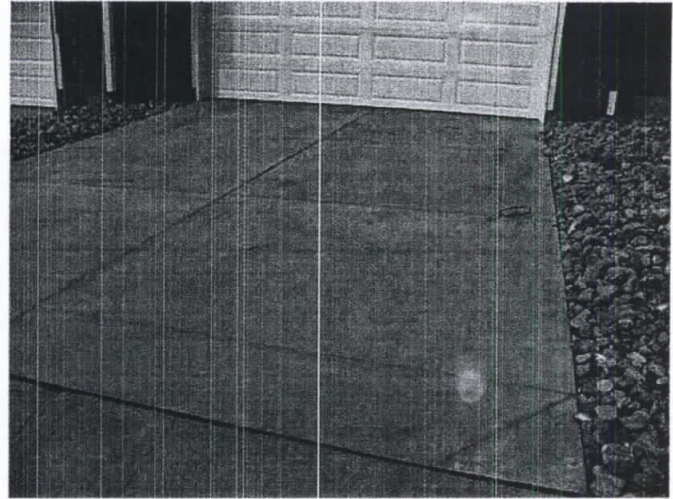
Comp #: 403 Concrete Driveways - Repair/Replace

There were sporadic areas of hairline cracks and spalling noted on several driveways at time of inspection. Majority of driveways were new and in good condition. Since it is unlikely that all concrete surfaces will fail at the same time, we suggest establishing a Reserve fund for periodic repairs and replacement to approximately 5% of the total area (1010 GSF) every 4 years. Repairs should be coordinated with other concrete surfaces for best cost estimate. As the property ages, the percentage or frequency of repairs may need to be adjusted in future Reserve Study updates.

Estimate to replace 5% of area every 4 years

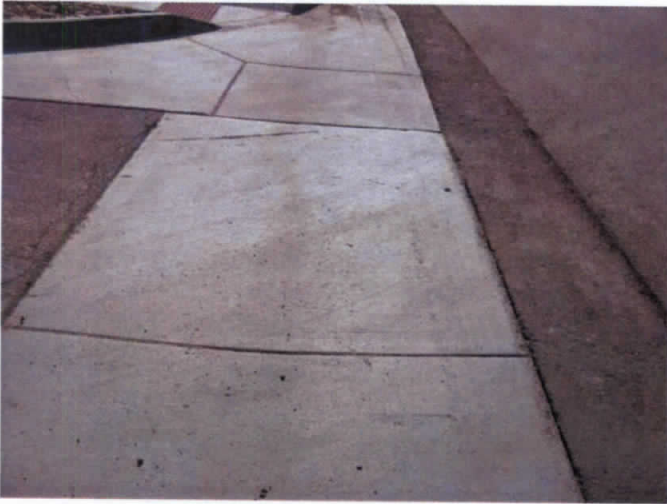
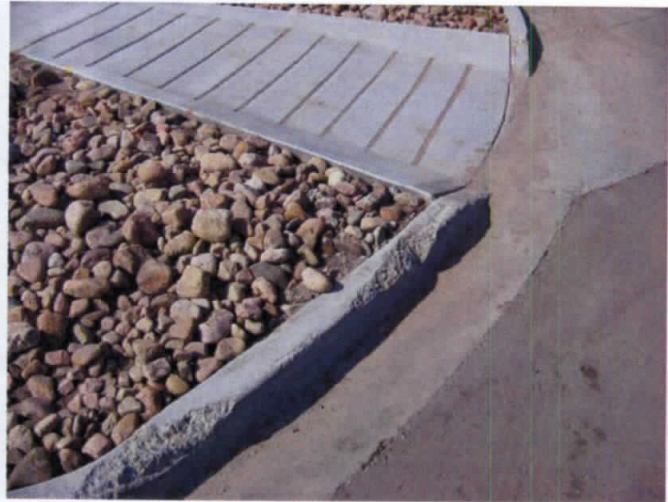
Comp #: 406 Drain Pans/Curb/Gutters - Repair

At the time of inspection, we noted some minor cracking and spalling of the drain swales. There were also noticeable cracked and broken curbs noted during the inspection. It is possible the builder will replace these broken curbs as the damage may have come from construction vehicles. Similar to other concrete surfaces, there is no expectation to completely replace concrete swales at the same time. Therefore, Reserve to make periodic repairs and replacements to approximately 10% of total area (1135 GSF) every 4 years. The remaining life is based on average condition.

Estimate to repair 10% of area every 4 years

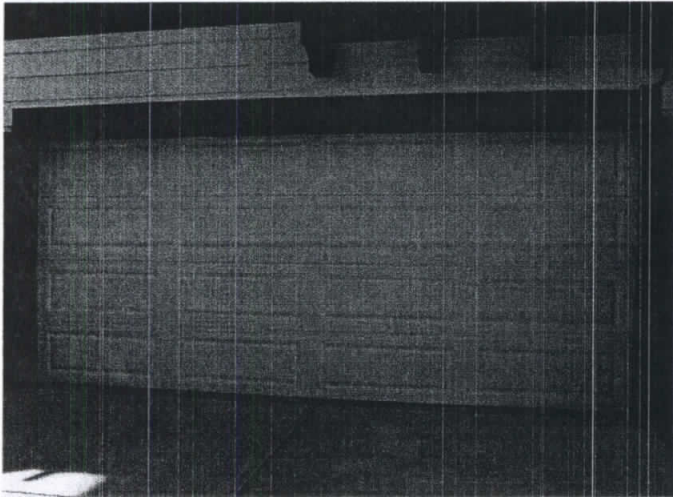
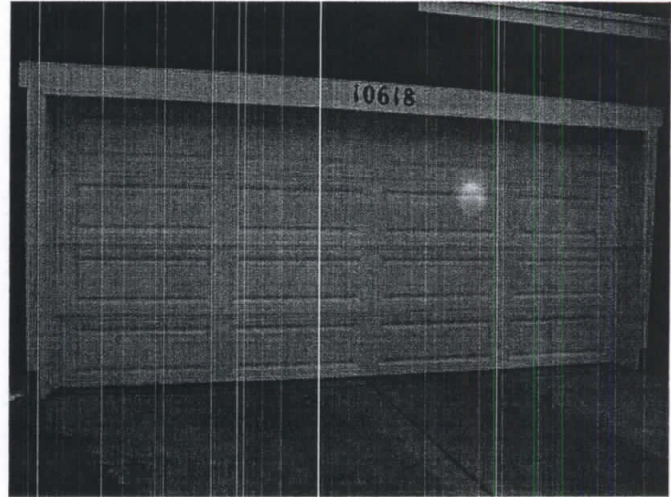
Comp #: 502 Garage Doors - Replace

No major problems observed with the garage doors at the time of inspection. According to Article 5.2.4, the owner shall be responsible for the maintain, repair, or replace garage doors, except for the painting or staining of surfaces. Unless otherwise noted, Reserve funding will not be included based on the rules stated in the declarations. We suggest the association establish a design guideline so that when an owner goes to replace a door, it will match and be consistent with the others.

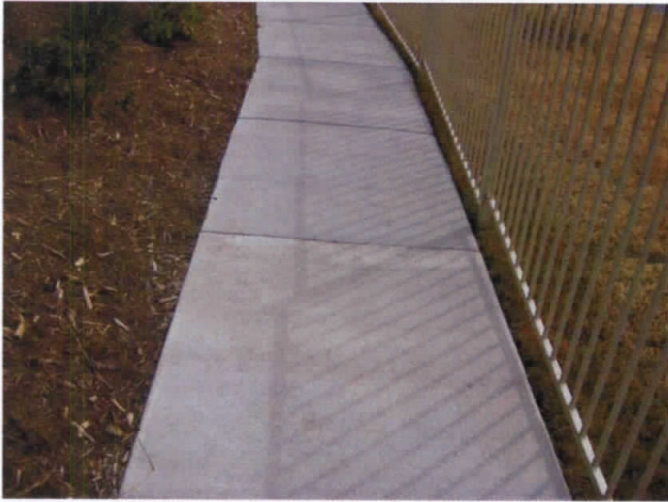
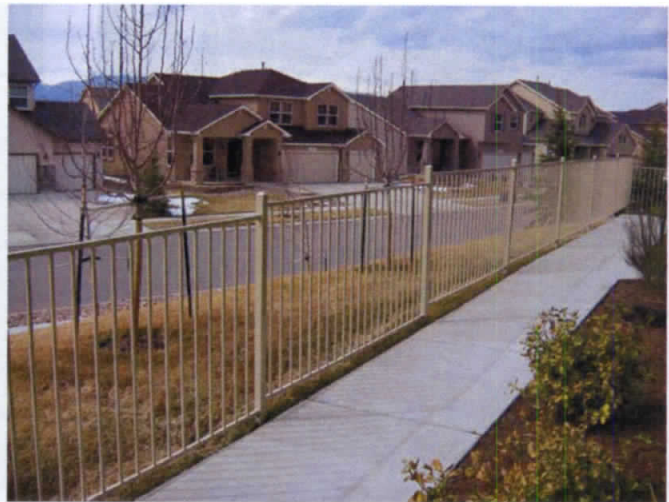
Comp #: 601 Concrete Sidewalks - Repair

All of the concrete surfaces are new and in good condition with only minor areas of cracking noted. Similar to other concrete surfaces, it is unlikely that all concrete surfaces will fail and need to be replaced at the same time. Therefore, we suggest establishing a Reserve fund for frequent repairs and replacement to a percentage of the area (5% or 1360 GSF) every 4 years. Coordinate repairs with other concrete surfaces for best cost estimate. As the property ages, the percentage or frequency of repairs may need to be adjusted in future Reserve Study updates.

Allowance to repair 5% of area every 4 years

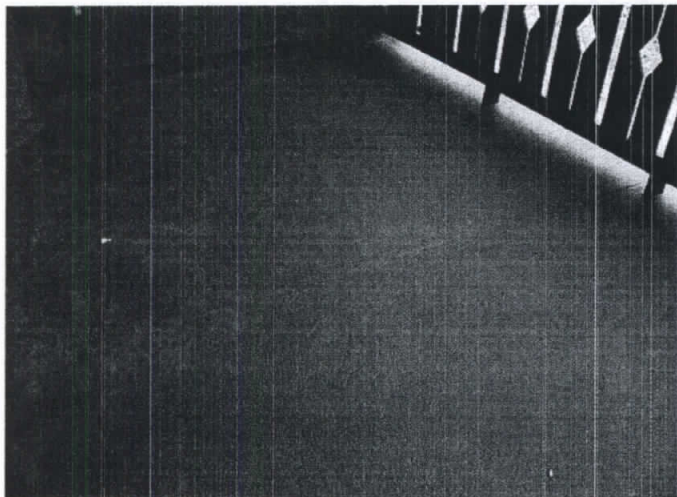
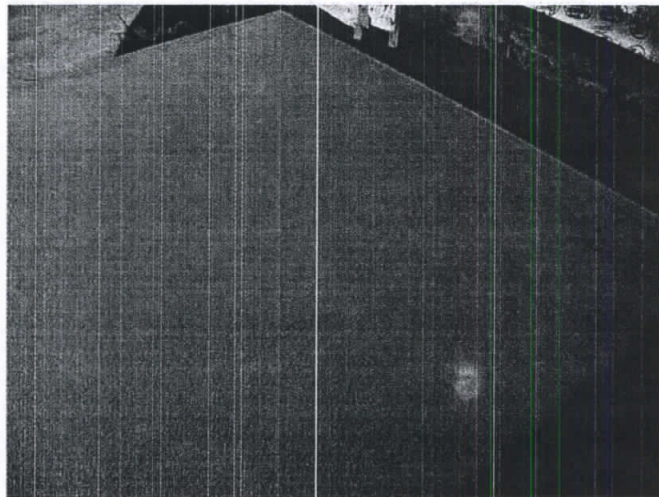
Comp #: 604 Vinyl Sheet Decking - Resurface

Decks are new and in good condition. The declarations do not specifically state who is responsible for the maintenance of the deck surfaces. Since each deck will be used on a different level by each owner, most associations determine the individual owner will be responsible for maintenance of the deck material. At this time, unless otherwise noted, Reserve funding will not be included for this component.

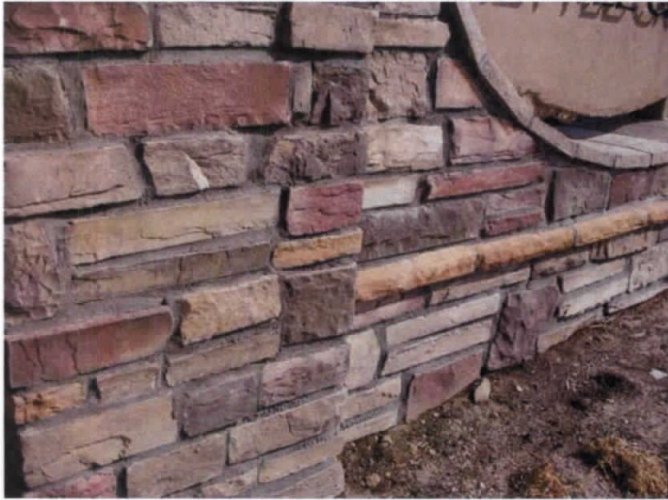
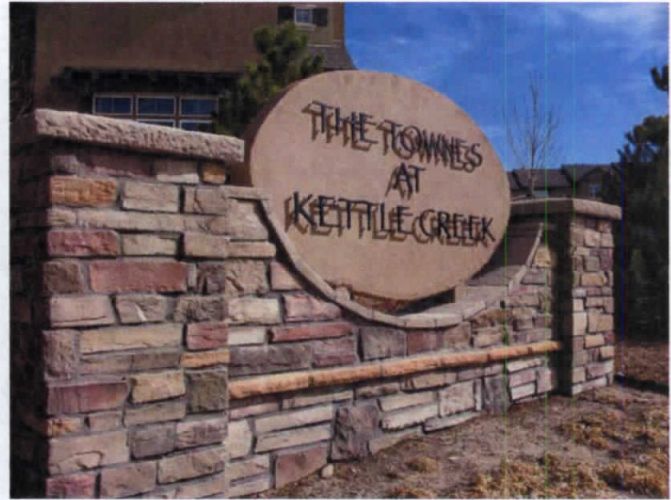
Comp #: 801 Monument - Rebuild

Structure is in good condition and very stable. While the materials used should have an indefinite life expectancy, we recommend planning on renovating monument every 20 - 25 years to maintain current trends and an appropriate appearance for the entrance to the community. The spot lighting should be replaced on an as needed basis with general maintenance funds, not Reserves.

Allowance for general repairs

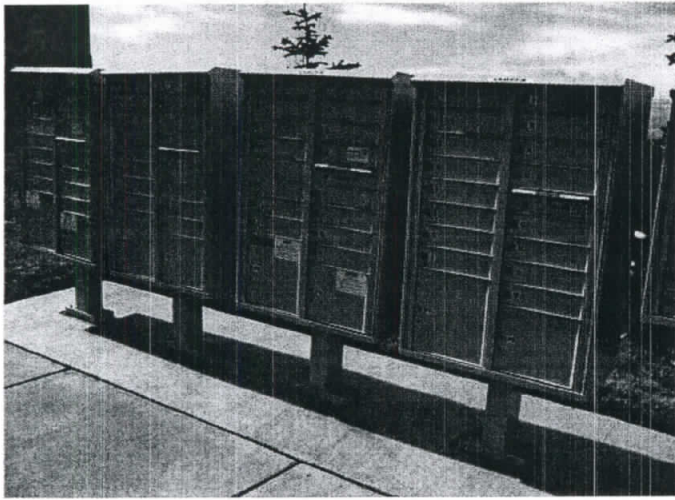
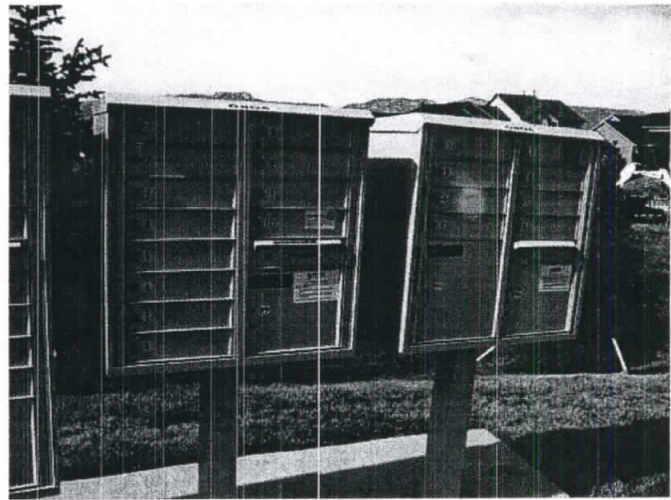
Comp #: 803 Mailboxes - Replace

All boxes are relatively new within the last year. The mailboxes used on this property were manufactured by Security Manufacturing Corp. The typical life expectancy for this type of mailbox is 15 - 20 years in this environment. Remaining life is based on average age of all units.

**Best Cost:** \$8,400  
\$1400/CBU; Estimate to replace

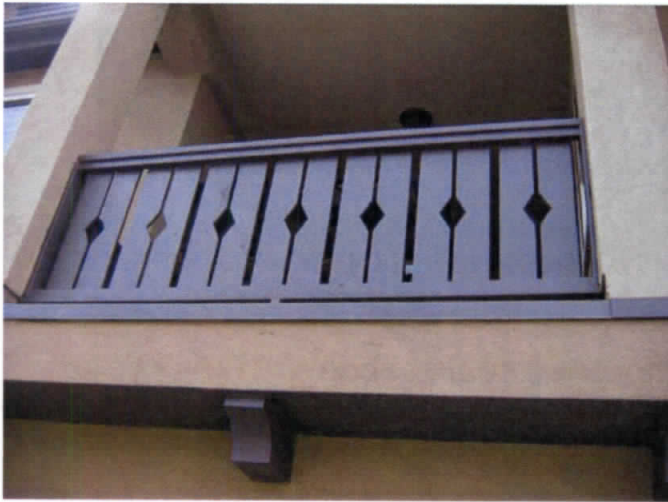
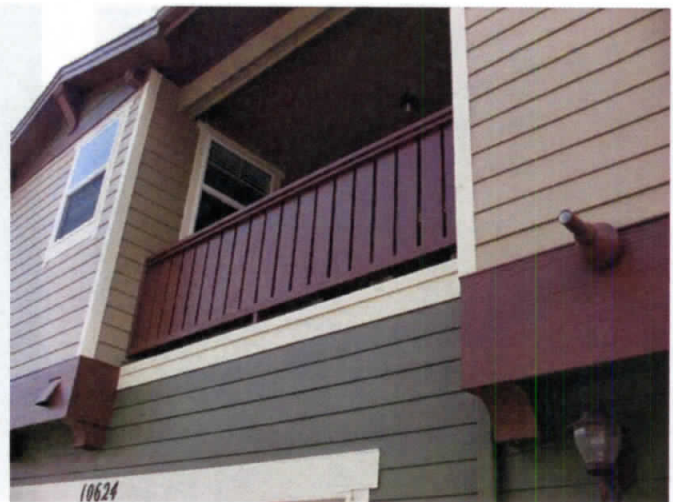
Comp #: 1001 Wood Handrails - Replace

The handrails are new and freshly painted. The life expectancy for this type of handrail is indefinite as long as proper maintenance and painting cycles are followed. These will not be subject to constant exposure to elements that will cause deterioration. Any minor repairs that are necessary shall be considered a general maintenance issue and should be done as part of prep work before painting.

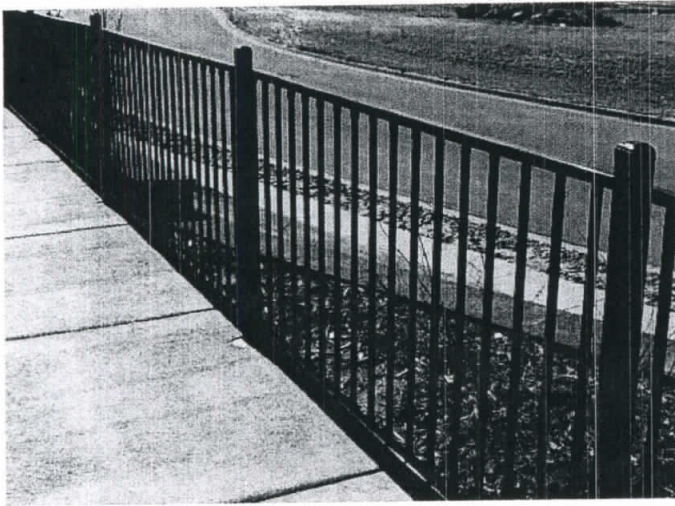
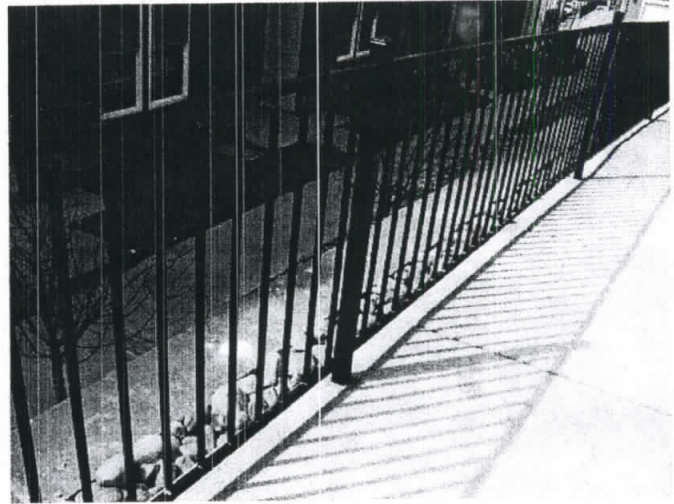
Comp #: 1002 Ironwork Handrails - Replace

Fencing is new and in good condition with no rusting or structural problems noted at the time of inspection. With regular painting and maintenance, expect a useful life of 25 to 30 years from this component. Remaining life based on current age.

*Best Cost:* \$74,250  
\$25/LF; Estimate to replace

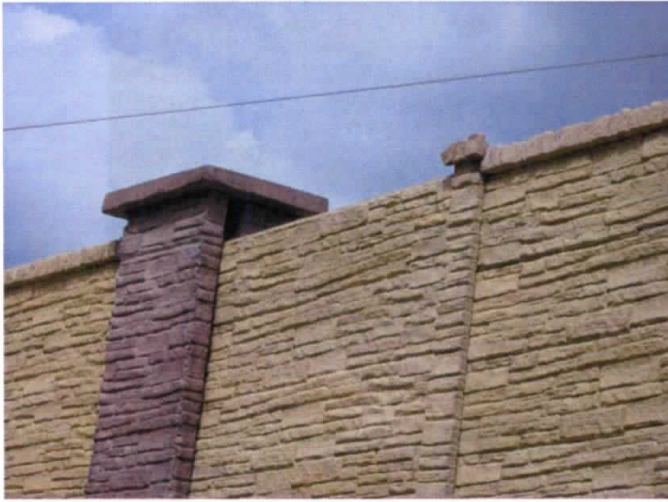
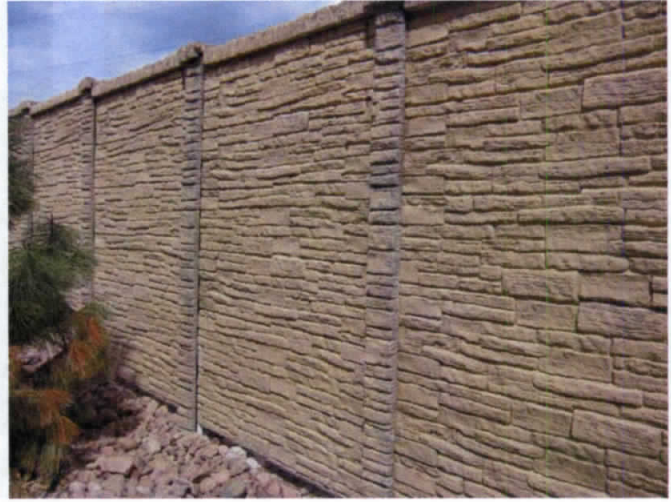
Comp #: 1003 Concrete Dry Stack Fence - Replace

There was some minor hairline cracking noticed in numerous panels throughout the fence. It was also noted during the inspection, that there was a cap missing by 3336 Ironton Creek Pt. According to the vendor, this material has a 10 year warranty against manufacturer defects. If moisture enters these cracks and with the temperature fluctuations, frequent cracking can be expected. While these panels can be replaced as needed, gradual replacement will result in a patch quilt appearance. Over a period of time, the appearance will cause eventual replacement.

**Best Cost:** \$76,950  
\$45/LF; Estimate to replace

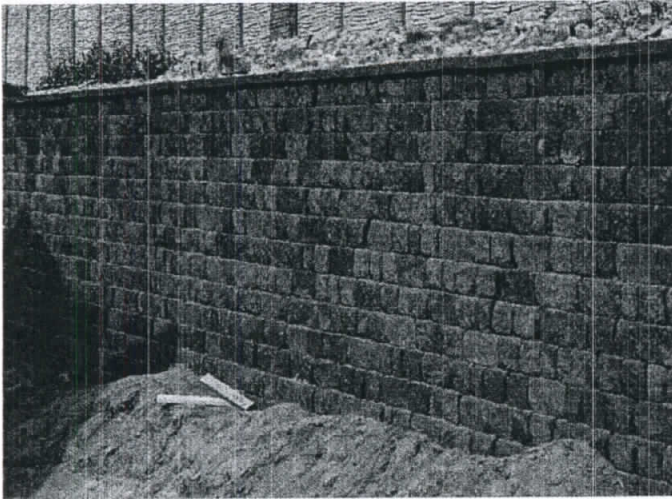
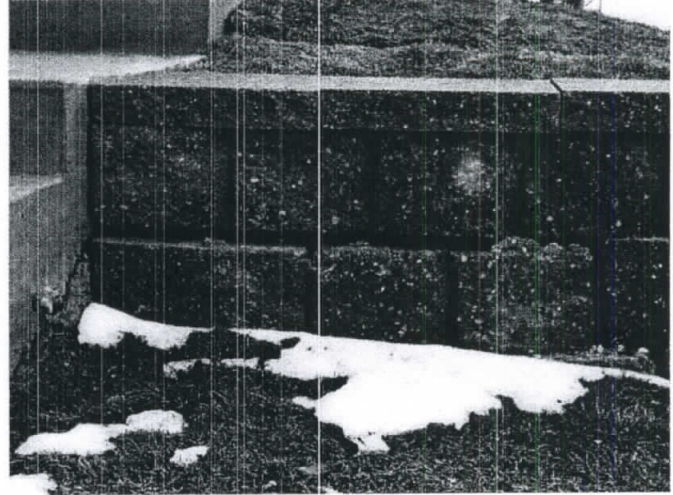
Comp #: 1005 Block Retaining Wall - Replace

No significant cracking or structural problems noted at the time of inspection. As long as block wall was installed conforming to county code this wall should have an extended useful life. No expectation to replace wall, reserve funding is not appropriate.

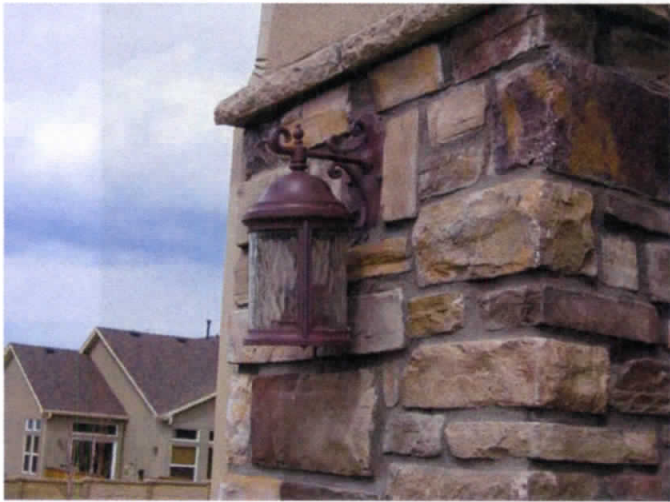
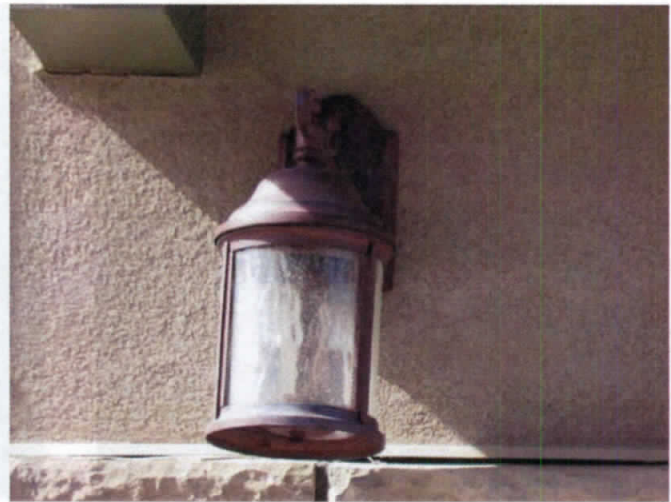
Comp #: 1602 Exterior Wall Mount - Replace

No unusual conditions were observed or reported at time of inspection. While replacement can occur on an as needed basis, it is our opinion and recommendation to replace all lights at the same time every 15 - 20 years to maintain a consistent appearance throughout the property. In addition, by replacing multiple fixtures, the association will be able to obtain a quantity discount for the fixtures. Estimated replacement cost includes labor for installation. The remaining life is based on the average age of all fixtures.

**Best Cost:** \$15,600  
\$95/light; Estimate to replace

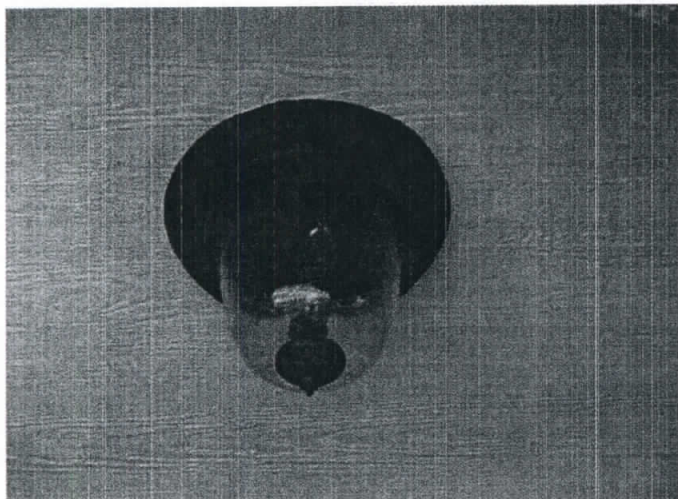
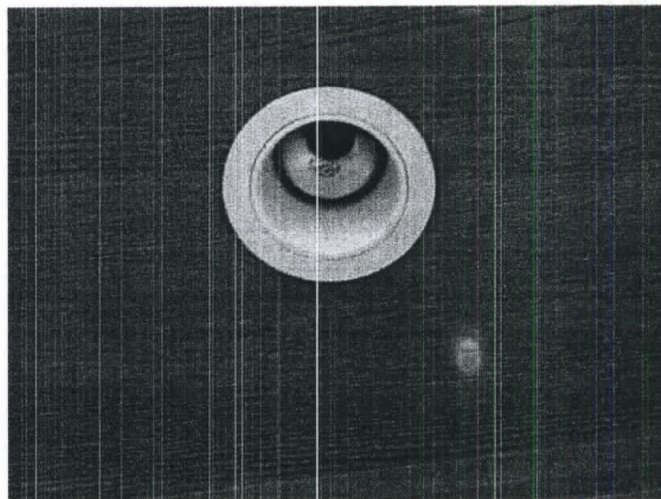
Comp #: 1608 Ceiling Lights - Replace

No unusual conditions were observed or reported at time of inspection. While replacement can occur on an as needed basis, it is our opinion and recommendation to replace all lights at the same time every 15 - 20 years to maintain a consistent appearance throughout the property. Replacement of these lights coordinate with the wall sconces to match décor of future lights. In addition, by replacing multiple fixtures, the association will be able to obtain a quantity discount for the fixtures. Estimated replacement cost includes labor for installation. The remaining life is based on the average age of all fixtures.

\$110/light; Estimate to replace

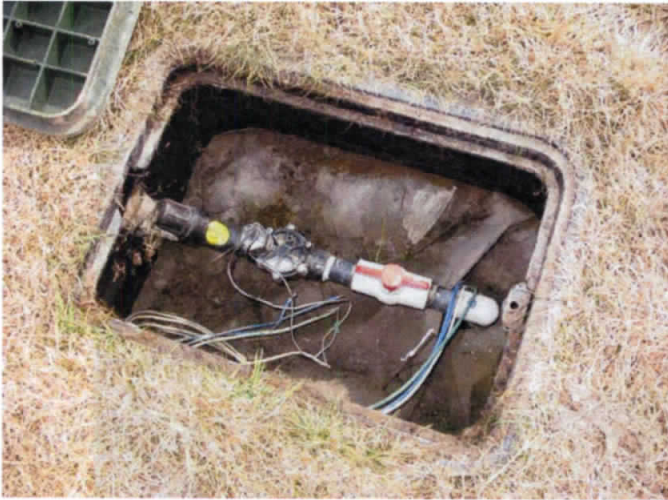
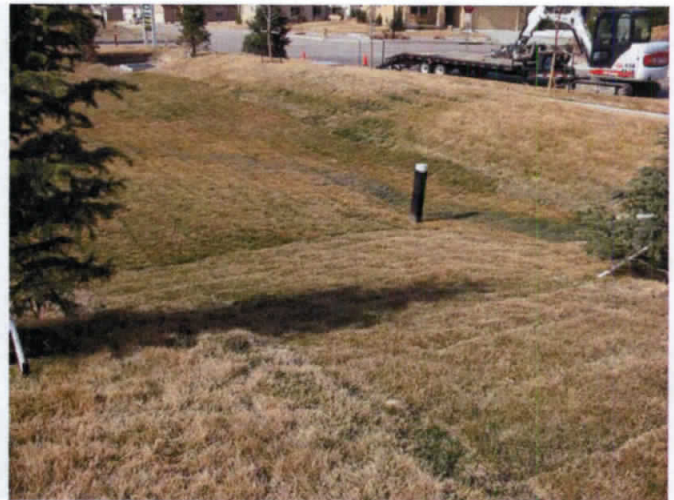
Comp #: 1701 Irrigation System - Rebuild

Most of the system was still being installed at time of inspection. The materials used during construction should have a long life expectancy with proper maintenance. At this time, there is no expectancy to completely replace the system and Reserve funding is not recommended. We recommend the association establish a line item in the general operating budget for annual repairs to necessary components of the system (broken lines, sprinkler heads, valves, backflow preventers, etc). If it later turns out that replacement will be necessary, expect to spend approximately \$150,000 (\$3,000 per zone) for a new system.

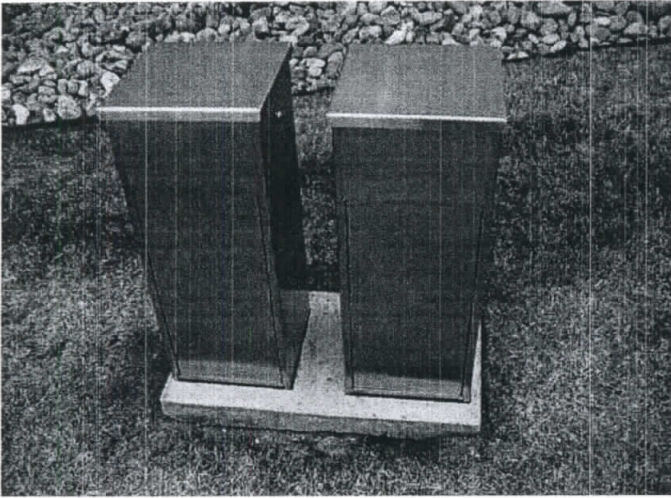
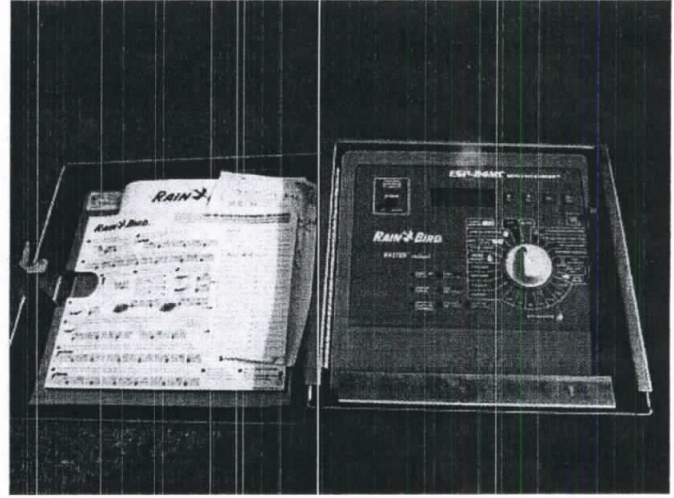
Comp #: 1703 Irrigation Timeclocks - Replace

System was winterized at time of inspection, so we were unable to test the function of the clocks. The timeclocks are new and should be in good condition. Under normal conditions (not including Acts of God, vandalism, etc.) these clocks should last 10 - 12 years with proper maintenance. The remaining life is based on the age of the clocks.

*Best Cost:* \$5,000  
\$2500/clock; Estimate to replace
