## “Full” Reserve Study

## Townes at Kettle Creek Colorado Springs, CO

**Report #: 24561-0**  
**For Period Beginning: January 1, 2014**  
**Expires: December 31, 2014**

**Date Prepared: October 10, 2013**

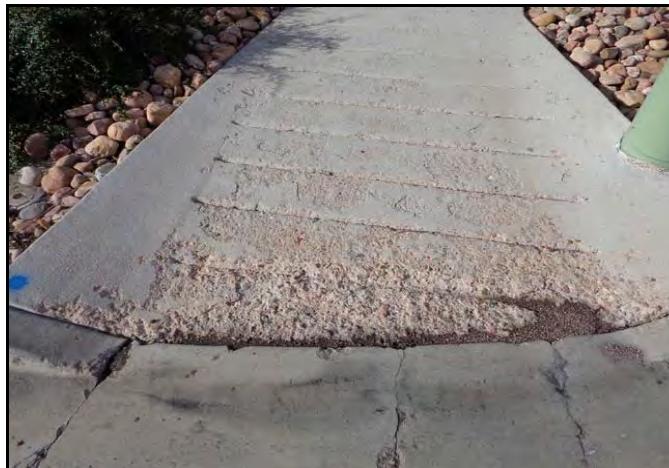
**Client: 24561A Townes at Kettle Creek HOA****Comp #: 103 Concrete Sidewalk - Repair (part)**

Evaluation: Concrete sidewalks are in overall good condition with any remaining damaged areas reportedly being replaced in 2013. Recommend ongoing inspections and repairs to any trip hazard areas first, then seal and repair any developing cracks over 1/4" wide to mitigate moisture penetration and prevent deterioration.

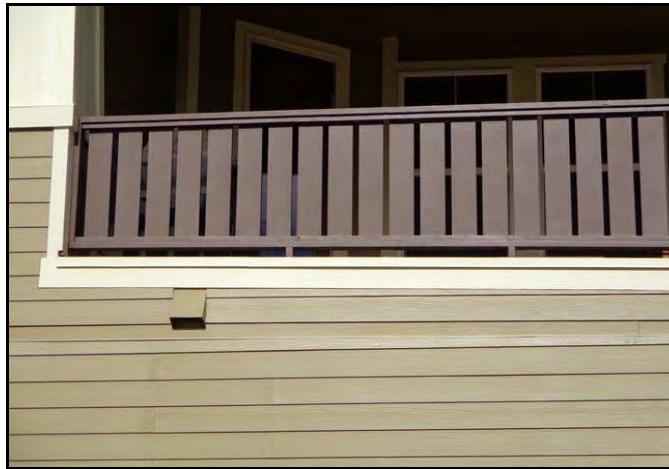
**Comp #: 109 Deck - Repair (part)**

Evaluation: Decking was not closely inspected due to access issues but appears in overall good condition with no significant signs of damage. Allowance is to repair decking and seal as needed, with no anticipation of replacing all of the decking at the same time.

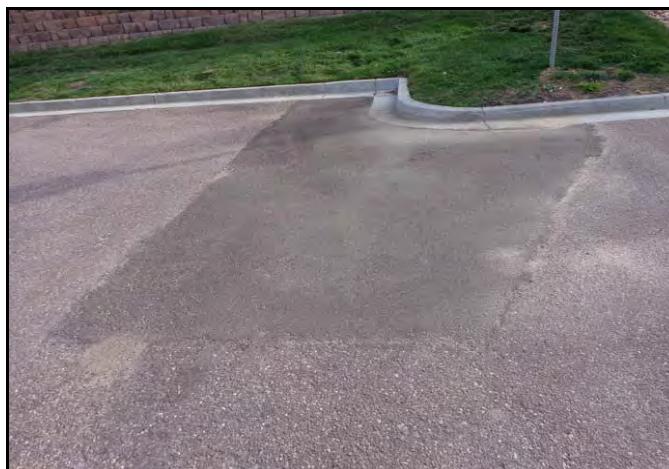
Evaluation: Asphalt appears in overall good condition with some signs of edge and surface cracking and patches in some areas. Recommend repairing any cracks to mitigate moisture penetration, which will accelerate subsurface deterioration of the asphalt.

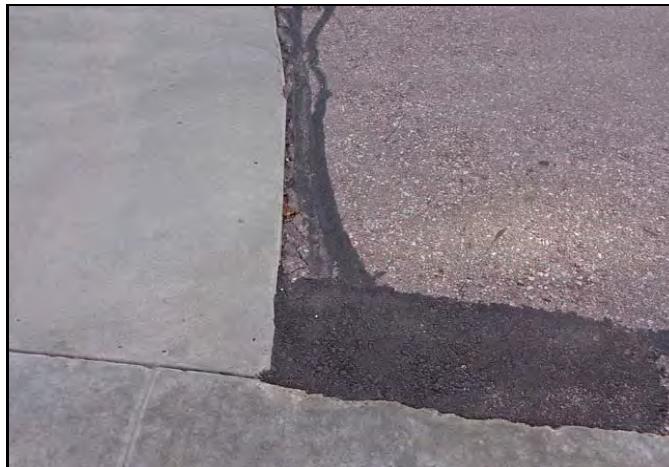
**Comp #:** 202 Asphalt - Crack Fill

Evaluation: Recommend yearly inspections and crack/fill work to mitigate any subsurface moisture. Subsurface moisture and loads typically contribute to accelerated deterioration. Also, timing (what month) is important in when crack/fill work should be completed in order to take advantage of maximum shrinkage (expanding crack) and workability of materials.

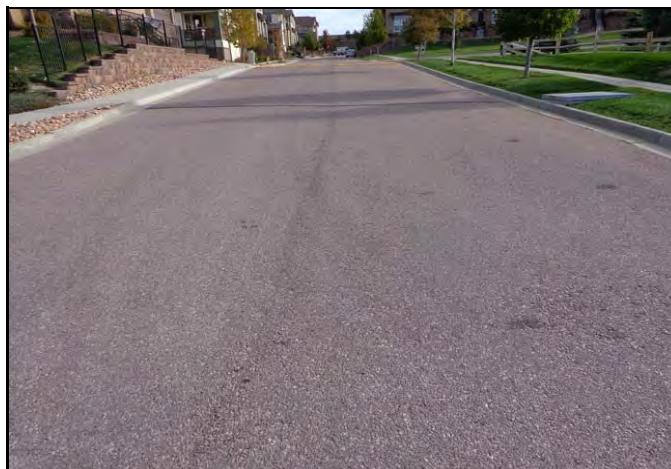
**Comp #:** 202 Asphalt - Seal/Repair

Evaluation: Asphalt surface is in fair to poor condition with significant dryness and loss of seal material noted. Seal coating does not add any structural integrity to the asphalt. However, seal coating protects the asphalt from UV deterioration and fills cracks typically no larger than 1/16". Recommend yearly inspections and crack/fill work to mitigate any subsurface moisture.

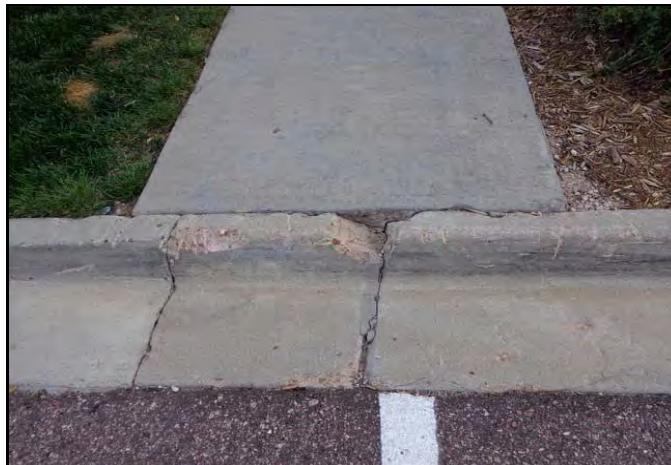
**Comp #:** 204 Conc. Curb/Gutter - Replace (part)

Evaluation: Concrete curb and gutters are in overall good condition with isolated areas of chips or cracks which reportedly will be replaced in 2013. On an ongoing basis, repair and replace curb and gutter to mitigate any subsurface moisture. Cycle this component with asphalt repair work when possible.

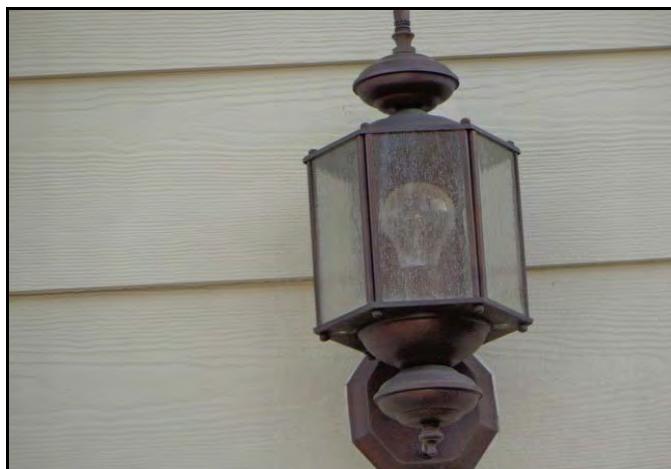
**Client: 24561A Townes at Kettle Creek HOA****Comp #: 324 Exterior Wall Lights - Replace**

Evaluation: Metal light fixtures with single bulbs mounted on exterior of the units are in good condition. Bulb replacement is the responsibility of the homeowner. As fixtures age, uniformed replacement will be necessary to maintain an aesthetic appeal.

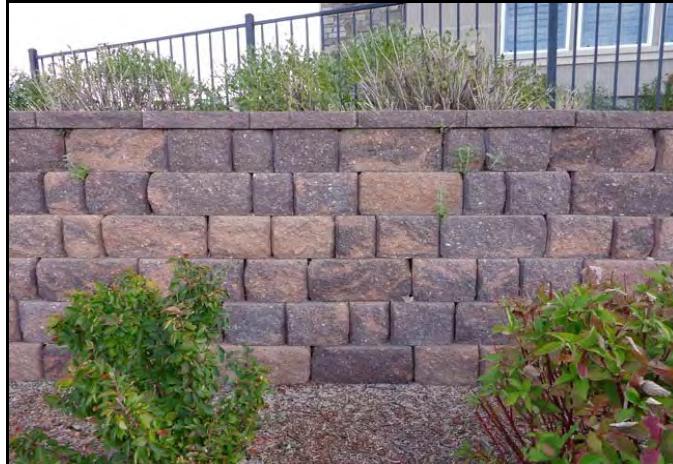
**Comp #:** 501 Block Wall - Repair (part)

Evaluation: Extensive MSE (Mechanically Stabilized Earth Walls) are located throughout the community and appear in overall good condition. Walls are usually constructed with masonry block, geo-grid, select fill material, and drainage pipe at bottom of wall. Recommend periodic inspections to ensure wall is intact and no signs of movement are observed. These type walls tend to have a very long useful life (50 to 75 years) if maintained properly. Allowance is to repair walls as needed, with no anticipation of complete replacement at one time.

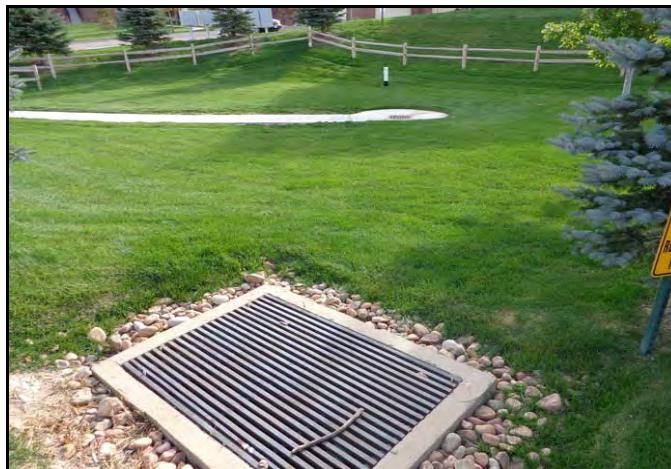
Evaluation: No drainage problems were reported at the time of our inspection. The system is assumed to have been properly designed with adequate provisions for community drainage needs. As routine maintenance, inspect regularly, keep drains and grates free of debris and free flowing to ensure water evacuating as designed. Pump out sediments if needed utilizing mobile evacuator service; fund from operating budget. No expectation of large scale repairs/replacement at this time. No reserve funding suggested.

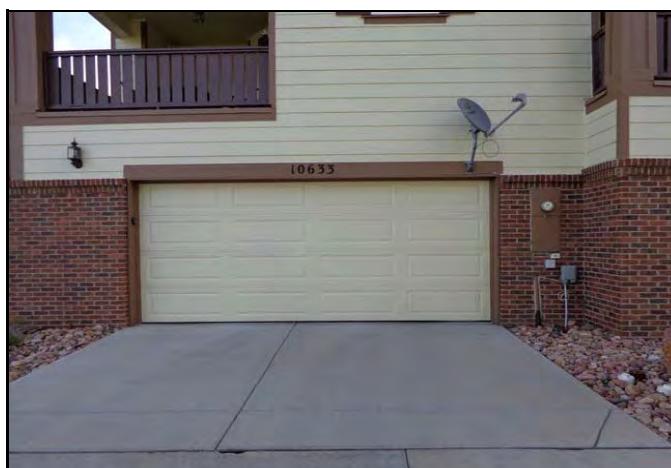
Evaluation: The metal roll up garage doors are reported to be the responsibility of the unit owners to replace. Recommend regular paint, in conjunction with other exterior paint projects to maintain appearance and protect the metal surface from the elements. No reserve funding is recommended.

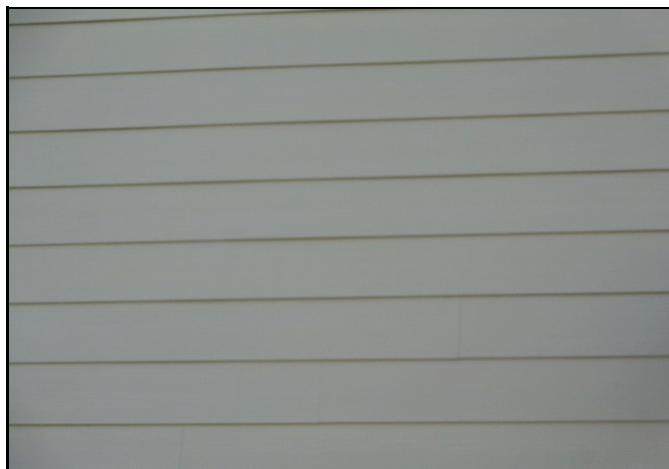
Evaluation: Paint is in overall good condition with a major project recently completed in 2013. Recommend inspecting annually and caulking around areas of wood to stucco transition where necessary. Preventing moisture penetration via cracks (wood shrinking around stucco, or at transitions) is critical in maintaining exterior components.

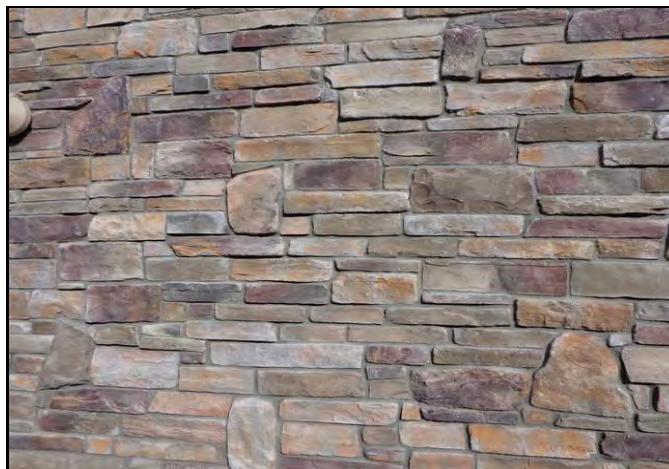
Evaluation: Synthetic stone is in variable dimensions around the base and face of the buildings and is used to provide aesthetic appeal. Stone appears to be in good condition but may loosen periodically. Allowance should be used to inspect and repair or re-secure material and repoint grout as needed.

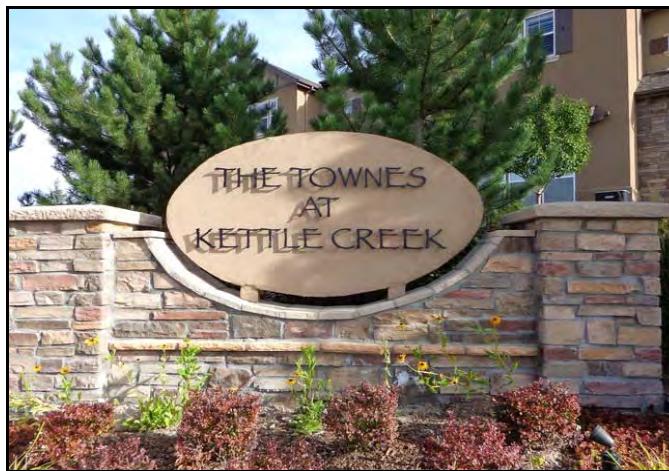
Evaluation: Monument sign is in good condition with no signs of cracked stucco, missing stone or missing finish on the lettering. Funding is to refurbish monuments periodically to maintain the appearance of the community.

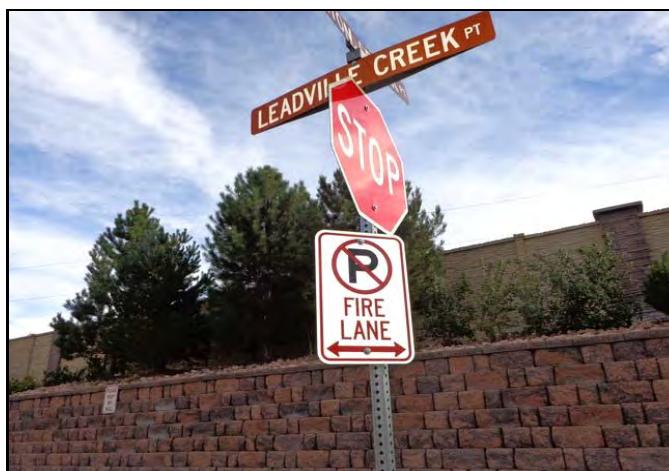
Evaluation: Informational, entry and street signage is located throughout the community and at common areas, and appears to be in overall good condition. Funding is to replace portions due to wear, age and vandalism.
